Editor's Note: Within an hour after launch, NASA's WIRE (Wide-Field Infrared Explorer) spacecraft prematurely discharged its cryogen, ending the mission. The failure is recounted below (The full NASA report is available online at http://klabs.org/frichcontent/Reports/nasa_wire_lesson.pdf).

The Loss of WIRE

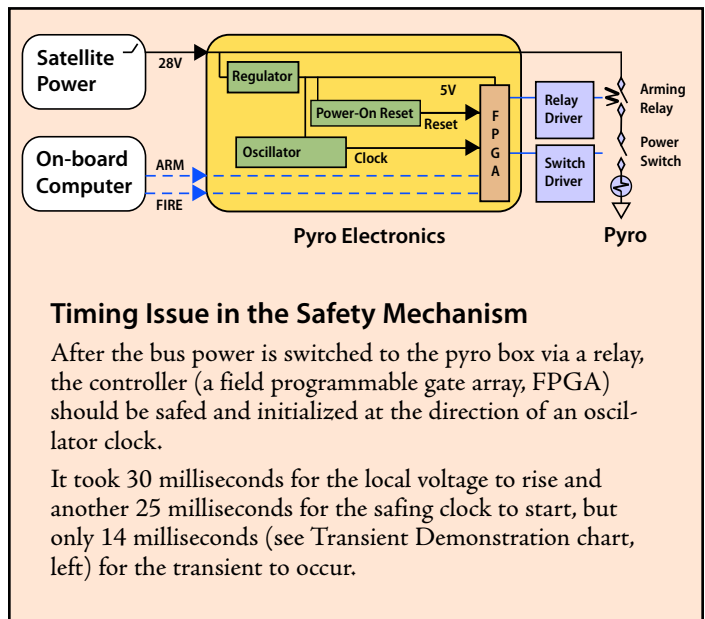
Timing Issue in the Safety Mechanism

After the bus power is switched to the pyro box via a relay, the controller (a field programmable gate array, FPGA) should be safed and initialized at the direction of an oscillator clock.

It took 30 milliseconds for the local voltage to rise and another 25 milliseconds for the safing clock to start, but only 14 milliseconds (see Transient Demonstration chart, left) for the transient to occur.
