*Editor's Note: Contact to the Solar and Heliospheric Observatory (SOHO) was lost in June 1998 due to ground controller errors, and control was not regained until three months later. In this issue we recount the events that led to the mishap; in the next issue we will discuss SOHO's dramatic rescue.*

## SOHO in Trouble

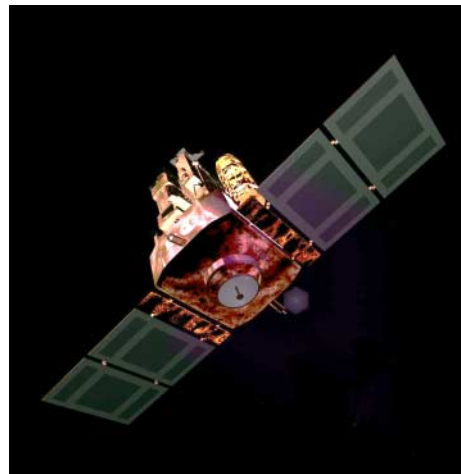
*SOHO weighs about two tons and with its solar panels extended stands about 25 feet across. It was launched in December, 1995. SOHO will continue operating well past the next solar maximum in 2001.*
